THERMOGRAPHIC ANALYSIS OF THE RICOMA 2 HEAD EMBROIDERY MACHINE

Abstract: *The purpose of this paper is to quickly and accurately identify the points representing potential defects in 2 head embroidery machines by using infrared thermography. Thermography measurements were performed with the FLIR SC 640 thermal imaging camera, which is a portable thermographic scanning equipment. The Flir Reporter 9.1 software is used to create reports based on photos taken with the Flir Sc 640 thermal imaging camera. Measurements were taken on the Ricoma 2 head embroidery machine at different work patterns to track the way the needle temperature is transmitted on the fabric on which the embroidery patterns are made. The measurements were taken for several materials and the material chosen to be presented in the present paper is a synthetic and natural fiber compound, because of its large dimensional stability. In this paper the results of thermography measurements on the chosen material are presented at a minimum working regime of 300 sinkings/min, at the optimal working regime determined by the authors to be 790 sinkings/min and at the maximum working regime of 900 sinkings/min .*

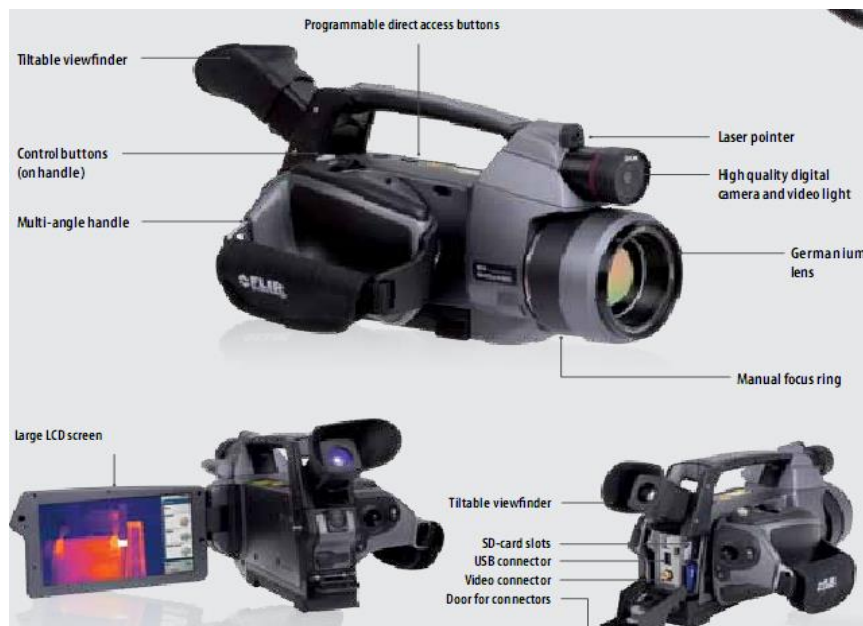
Fig. 1. The component elements for Thermo Camera Flir SC640 [2,3,4]

According to Figure 1, the thermo camera is equipped with a laser pointer, germanium lens, SD card, USB and Video connector [2,3,4]

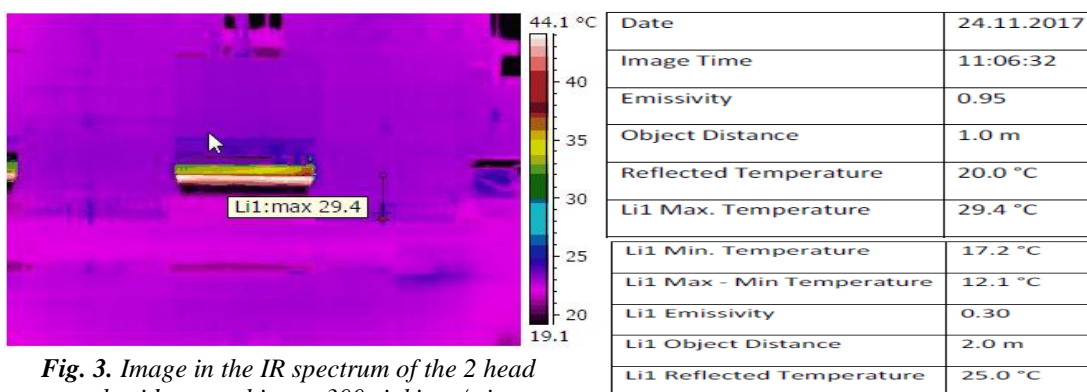
Fig. 3. Image in the IR spectrum of the 2 head embroidery machine at 300 sinkings/min

In (Figure 3) can be seen the graphic slider that is positioned on the needle and indicates a temperature of 29.4 ° C. The measurement distance was of 1m between the camera and the 2 head embroidery machine and the air temperature was 20 ° C. In (Figure 4), the needle temperature variations are displayed at 300 sinkings/min for the first embroidery pattern.

Following the measurements of the RICOMA 2 head embroidery machine on the chosen material, at 300 sinkings/min the needle temperature was recorded as 29.4 ° C. At 790 sinkings/min, the needle temperature increases to 46.8 ° C and at 900 sinkings/min the temperature of the needle reaches a significant value of 60.3 ° C.

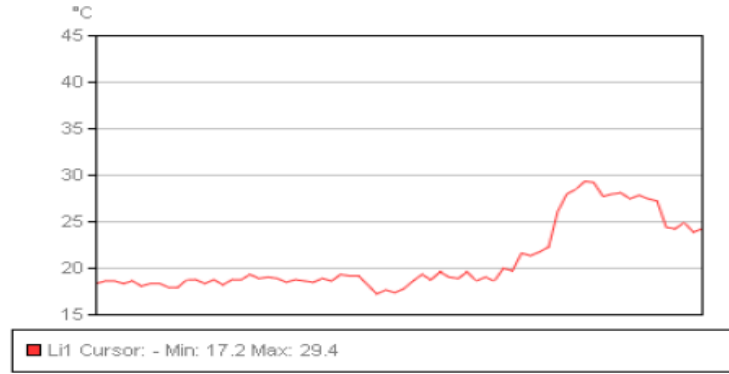
Fig. 4. Variations of the needle temperature at 300 sinkings/min.
