## THERMOGRAPHIC STUDY ON TEXTILE TREATMENT EQUIPMENT

**Abstract:** *The thermal analysis of the equipment in this work paper, has an important role (for planning maintenance activities), because this machine ensures optimal loading with different material treatment solutions, intended for mattresses, according to customer requirements. In the present paper the authors conducted a research on the whole technological flow in order to plan predictive maintenance activities using online monitoring methods. The monitoring of machine conditions is very important from the viewpoints of productivity, economic benefits, and maintenance. With one motor not functioning, the ventilation system may not be able to circulate enough air to properly cool the treated material. This can lead to overheating and potential damage to the material. Without all motors working together, the airflow and temperature within the treatment equipment may become uneven. The increased heat caused by a lack of proper ventilation can also harm the equipment itself, potentially causing mechanical failures or other issues. The failure of one ventilation motor can have significant negative impacts on the overall perfo

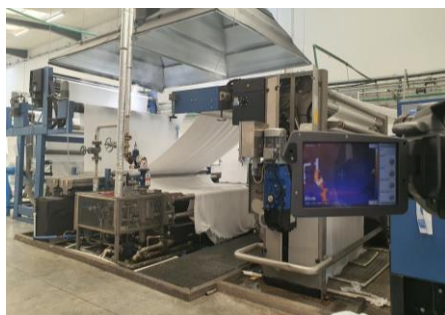
Thermographic measurements were performed on the Squeezing Pader Machine, which is a machine for treating textile materials (mattress covers), as shown in Fig. 1. As it can be seen from Fig. 3 the maximum temperature along line Li1, which is positioned on motor 1, is  $89.9^\circ\text{C}$ , and the minimum temperature is  $77.6^\circ\text{C}$ . The temperature variation along line Li1 is  $12.3^\circ\text{C}$ , and the emissivity is 0.85 along line Li1, positioned on motor 1. The maximum temperature along line Li2, which is positioned on motor 1, is of  $65.6^\circ\text{C}$ , and the minimum temperature is  $59.0^\circ\text{C}$ . The temperature variation along the Li2 line is  $6.5^\circ\text{C}$ , and the emissivity is 0.85 along the Li2 line, positioned on motor 1. The maximum temperature along line Li3, which is positioned on motor 1, is  $85.6^\circ\text{C}$  and the minimum temperature is  $65.1^\circ\text{C}$ . The temperature variation along line Li3 is  $20.5^\circ\text{C}$ , and the emissivity is 0.85 along line Li3, positioned on motor 1.

Fig. 1: Equipment for the treatment of textile materials [8]

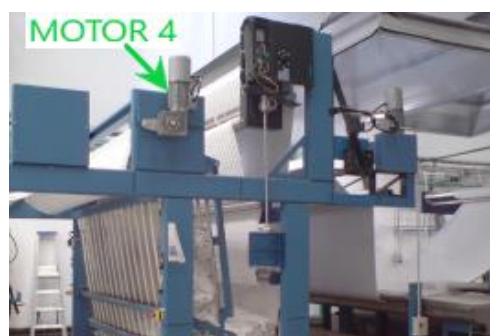
Image Camera Type	FLIR SC640
Li1 Max. Temperature	39.7 °C
Li1 Min. Temperature	35.5 °C
Li1 Max - Min Temperature	4.2 °C
Li1 Emissivity	0.85
Li1 Object Distance	2.0 m
Li1 Reflected Temperature	22.5 °C
Li2 Max. Temperature	39.8 °C
Li2 Min. Temperature	35.3 °C
Li2 Max - Min Temperature	4.5 °C

Li2 Emissivity	0.85
Li2 Object Distance	2.0 m
Li2 Reflected Temperature	22.5 °C
Li3 Max. Temperature	39.9 °C
Li3 Min. Temperature	35.5 °C
Li3 Max - Min Temperature	4.4 °C
Li3 Emissivity	0.85
Li3 Object Distance	2.0 m
Li3 Reflected Temperature	22.5 °C

Fig. 5: IR and real spectrum image of motor 4 and temperatures along the measured lines: (a) infrared image, (b) real image.

As it can be seen from Fig. 5 the maximum temperature along line Li1, which is positioned on motor 4, is 39.7°C, and the minimum temperature is 35.5°C. The temperature variation along line Li1 is 4.2°C, and the emissivity is 0.85 along line Li1, positioned on motor 4. The maximum temperature along line Li2, which is positioned on motor 4, is of 39.8°C, and the minimum

temperature is 35.3°C. The temperature variation along the Li2 line is 4.5°C, and the emissivity is 0.85 along the Li2 line, positioned on motor 4. The maximum temperature along line Li3, which is positioned on motor 4, is 39.9°C and the minimum temperature is 35.5°C. The temperature variation along line Li3 is 4.4°C, and the emissivity is 0.85 along line Li3, positioned on motor 4.

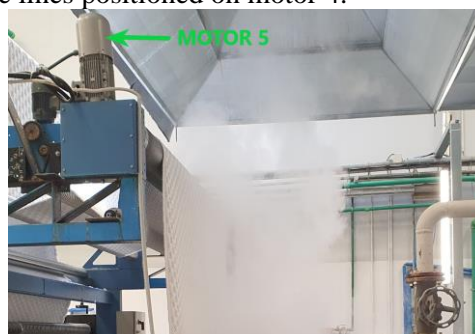
Image Camera Type	FLIR SC640
Li1 Max. Temperature	55.2 °C
Li1 Min. Temperature	36.5 °C
Li1 Max - Min Temperature	18.7 °C
Li1 Emissivity	0.85
Li1 Object Distance	2.0 m
Li1 Reflected Temperature	22.5 °C
Li2 Max. Temperature	55.3 °C
Li2 Min. Temperature	37.6 °C
Li2 Max - Min Temperature	17.8 °C

Li2 Emissivity	0.85
Li2 Object Distance	2.0 m
Li2 Reflected Temperature	22.5 °C
Li3 Max. Temperature	56.2 °C
Li3 Min. Temperature	37.8 °C
Li3 Emissivity	0.85
Li3 Max - Min Temperature	18.4 °C
Li3 Object Distance	2.0 m
Li3 Reflected Temperature	22.5 °C

Fig. 7: IR and real spectrum image of motor 5 and temperatures along the measured lines: (a) infrared image, (b) real image.

As it can be seen from Fig. 7 the maximum temperature along line Li1, which is positioned on motor 5, is 55.2°C, and the minimum temperature is 36.5°C. The temperature variation along line Li1 is 18.7°C, and the emissivity is 0.85 along line Li1, positioned on motor 5. The maximum temperature along line Li2, which is positioned on motor 5, is of 55.3°C, and the minimum temperature is 37.6°C. The temperature variation along the Li2 line is 17.8°C, and the emissivity is 0.85 along the Li2 line, positioned on motor 5. The maximum temperature along line Li3, which is

positioned on motor 5, is 56.2°C and the minimum temperature is 37.8°C. The temperature variation along line Li3 is 18.4°C, and the emissivity is 0.85 along line Li3, positioned on motor 5.
